Forensic Building Science, Inc.
657 Lincoln Avenue
St. Paul, MN 55105
T: 651.222.6509
www.forensicbuildingscience.com

Date: January 22, 2018

Property: Rocky Waters Motor Inn
333 Parkway,
Gatlinburg, TN 37738

This letter will serve as an interpretation with recommendations from our particulate matter sampling at the above referenced property. Air sampling and tape lift sampling was performed by Forensic Building Science (FBS) on January 4 and 5, 2018 in response to a recent brush fire.

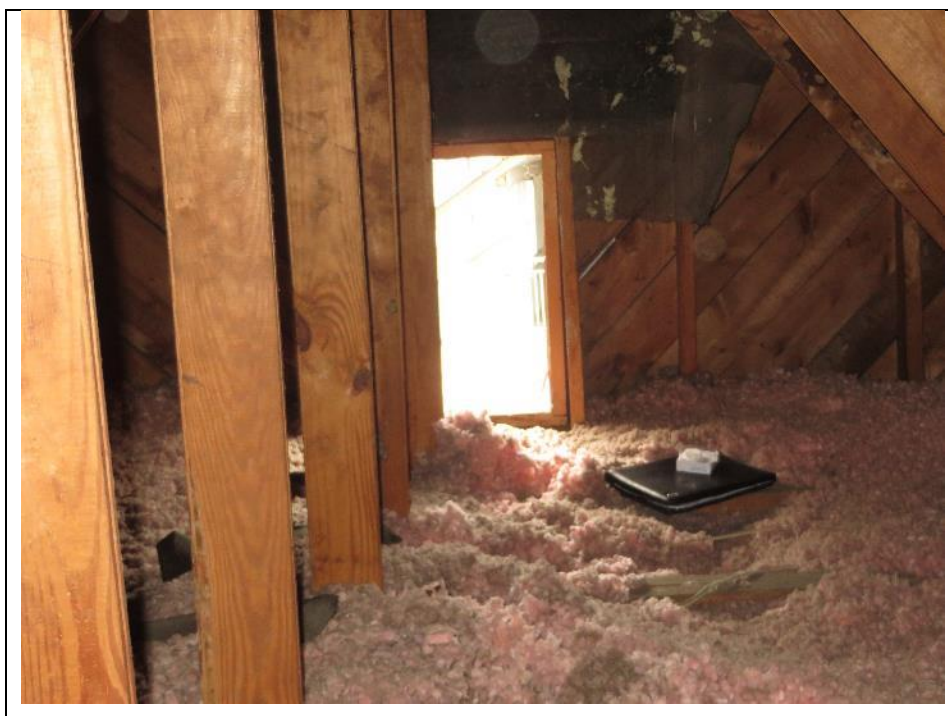
Figure 90. Attic space entry. (AP)

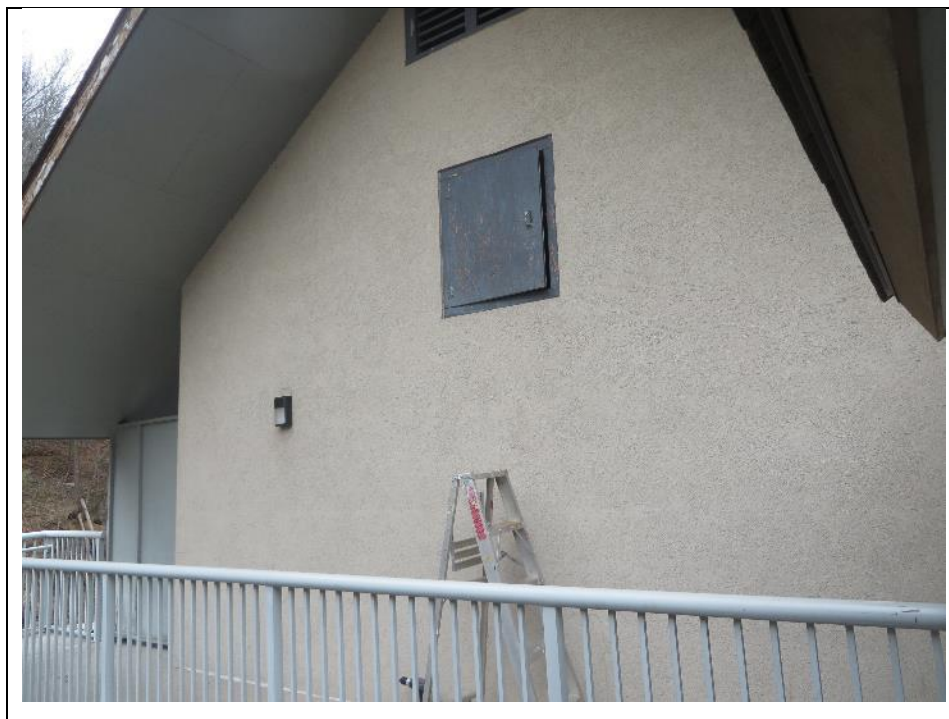
Figure 102. Attic space entry. (AP)

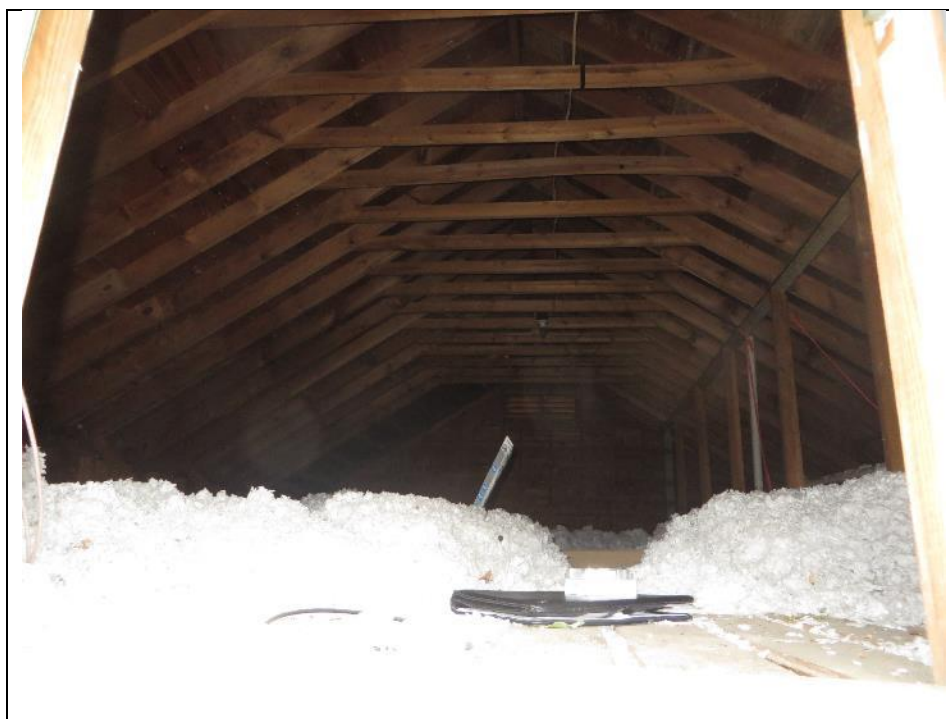
Figure 103. Attic space overview. (AP)

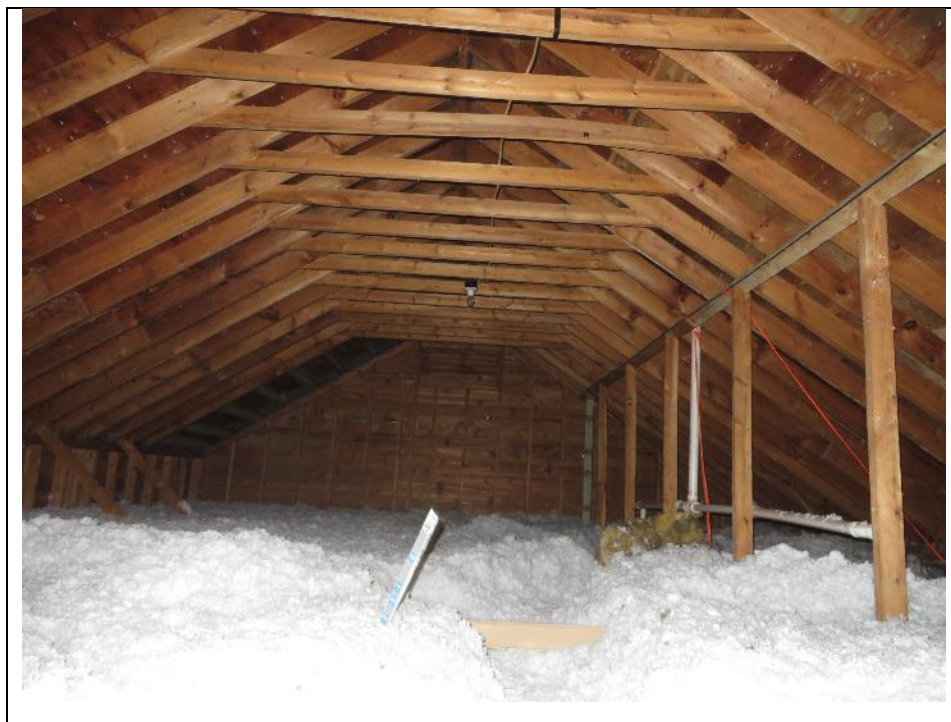
Figure 104. Overview continued. (AP)

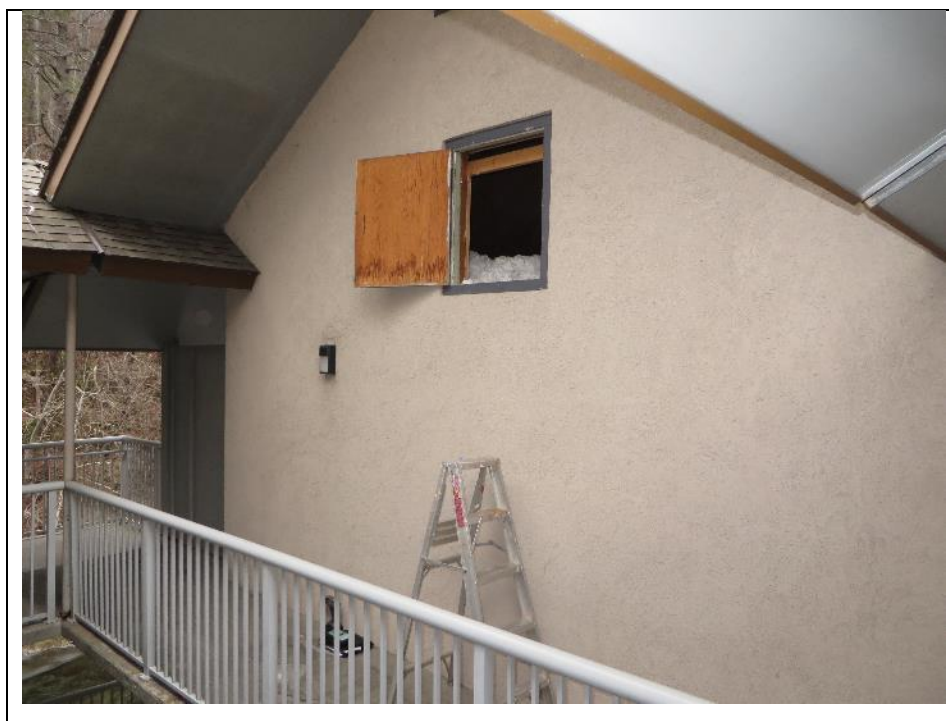
Figure 114. Attic space entry. (AP)
